***DEVELOPMENT AND APPLICATION OF DESIGN AND INSTALLATION
CHECKLIST FOR GULLY-DRAIN IN A MEAT PROCESSING FACTORY
BASED ON HYDRAULIC AND HYGIENIC ANALYSIS***

**A PROJECT REPORT SUBMITTED IN PARTIALLY FULFILLMENT OF THE
REQUIREMENT FOR THE**

BACHELOR OF PROCESS AND FOOD ENGINEERING

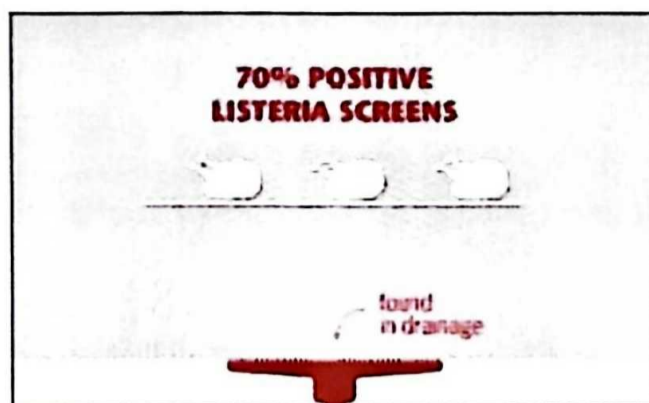
Figure 2.5 1: Possible cross-contamination due to bio aerosol occurrence from drainage

In food processing environment, drain components can be considered 'environmental surfaces' – with no direct food contact but with clear potential to act as a source of contamination (Fairley et al., 2014). Generally, issues related to the component design give rise to hygienic concern. Hygienic design of drainage includes continuous welding of joints, radiused corners and drainability (ACO, n.d.). The water trap used should be removable, can be separated for cleaning, improve water flow as compared to other traps. Drainage design will affect in-situ hygienic performances, poor drainage design might further facilitate initial microbial adhesion, promote localized sedimentation or settling of lipids. In fact in 2019, according to white paper by ACO Building drainage, 70% of positive listeria screens are found in drainage and floor environment in food and drink factories which can cross-contaminate the food nearby as in Figure 2.5.1 (ACO, 2019).

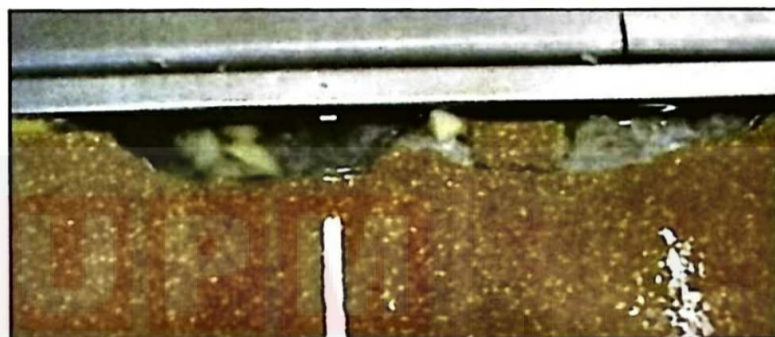
Figure 2.6 1 Poor floor-to-drain interface installation that can harbor microbial growth (EHEDG Doc 44, 2018)

In term of installation, the floor-to-drain interface is a potential spot for accumulation of wastewater that provide harbourage space for pathogen when not properly sealed off as in Figure 2.6.1 .

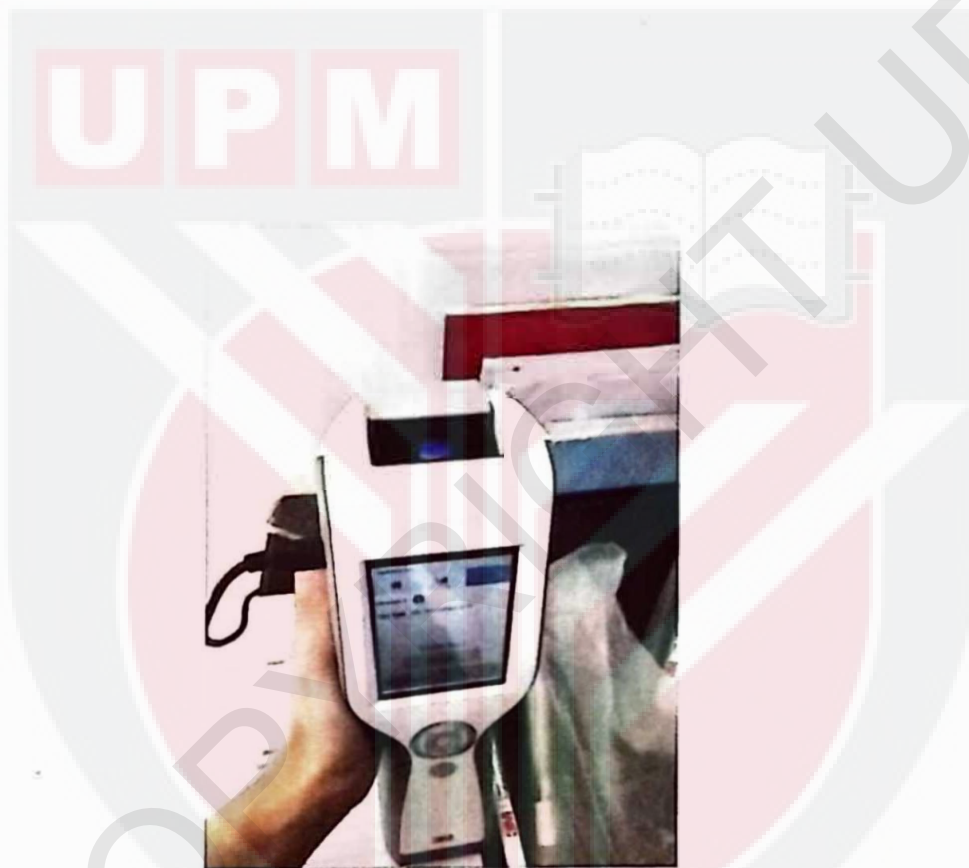
Figure 3.3 2: ATP illuminator

ATP bioluminescence assay is an analysis based on the measurement of ATP levels present on a surface after sanitation. Bioluminescence test exploits the chemiluminescence properties of luciferin-luciferase reagent, which reacts with any ATP residue present on a substrate, emitting light and measuring the presence of organic matter (Dancer, 2014). It is, therefore, an indicator of organic material presence, rather than microbial contamination. Some studies have found a correlation between ATP levels and total viable count (TVC) values (Amondio and Dino, 2014). A review on the use of ATP-bioluminescence in healthcare environments shows that the clean benchmark levels range from 100 to 500 RLU/100 cm² in healthcare or <500 RLU/100 cm² according to food industry practice (Amondio and Dinno, 2014).

stored in the chiller box before analysis. Swab test were performed at welding of joint near edge, drain surface, holes after cleaning event (3 readings for every location and every event and average reading is calculated). The samples were immediately analysed using 3 M™ Clean-Trace™ NGi Luminometer (3 M, Era Bumi , Malaysia) which measures the amount of light generated by chemical reaction, and produces a result expressed in Relative Light Units (RLUs). The intensity of the light is proportional to the amount of ATP and therefore, indicates the degree of contamination.

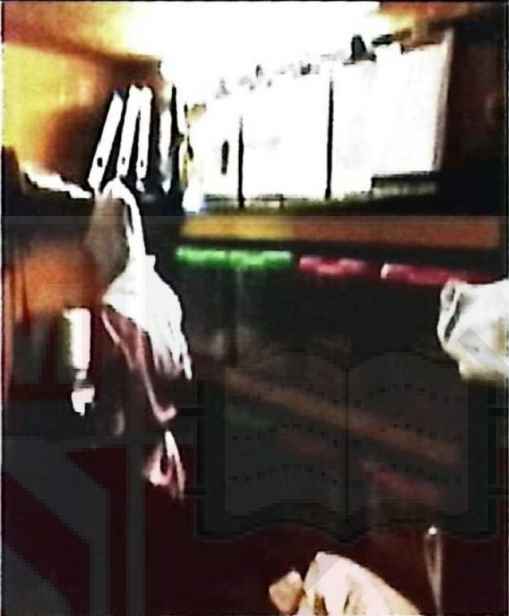
Process	Operation activities & objectives	Processing equipment	Illustration	Water consumption
1) Preparation of the raw materials	<ul style="list-style-type: none"> ◦ Removal of packing materials and weighing ◦ Weighing ◦ Printing of the packing labels with expiry dates 	<p>Minor weighing : electronic scale (maximal loading: 5 kg)</p> <p>Major weighing : platform scale (maximal loading: 300 kg)</p> <p>Semi-automatic date printing machines : 60-120 times/min</p>

No water is needed for this activity.

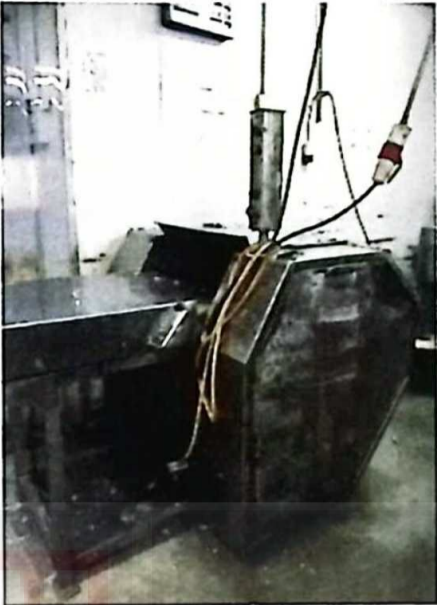
<p>2) Flaking of the frozen raw materials</p>	<ul style="list-style-type: none"> • Cutting of frozen materials (meat, fat and chicken skins) into 2 to 10 cm flakes for afterwards mincing without having to thaw • The reduced size avoids drip losses, bacterial growth and discoloration that often happen during thawing 	<p>Flaking: Flaker machine (2400 kg/h), compressed air necessary at minimum 4.14 bar</p> <p>Material transfer to the mincer machine: Euro bin (capacity 120 Litres)</p>

<p>Large amount of water is needed to wash off the meat flakes from the machine</p>
---	--	---	--	---

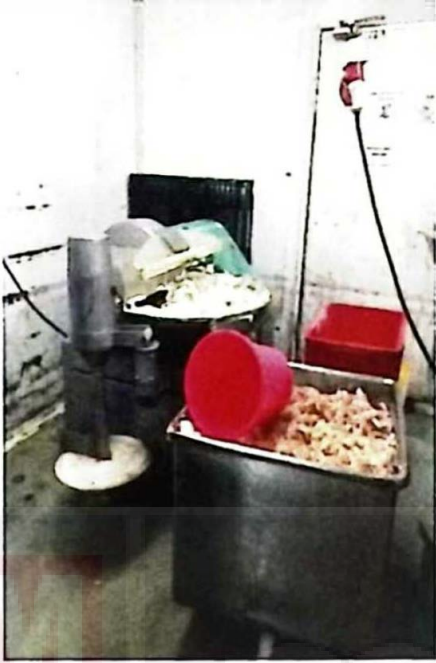
<p>3) Premixing of dry ingredients</p>	<p>- Mixing of the textured vegetable protein (TVP) and isolated soy protein (ISP) with cold water to produce finely comminute particle</p> <p>- The mixing was run for 5 minutes per loading by an operator in accordance to the recipe</p>	<p>Mixing: Bowl cutter (maximal capacity 33 kg/loading)</p> <p>Material transfer to the paddle mixer.</p> <p>Industrial tray of food grade 600 x 400 x 120 mm (capacity 23.7 Litres)</p>

<p>Medium amount of water is needed to wash the internal of the bowl cutter</p>
<p>4) Mincing of the frozen raw materials</p>	<p>- Refining of flakes from the flaker machine was into minces of the size 6 mm for round patty and 4.5 mm for oblong patty</p>	<p>Mincing: mincer machine (510 kg/h)</p> <p>Material transfer to the paddle mixer.</p> <p>Industrial tray of food grade 600 x 400 x 120 mm (capacity 23.7 Litres)</p>

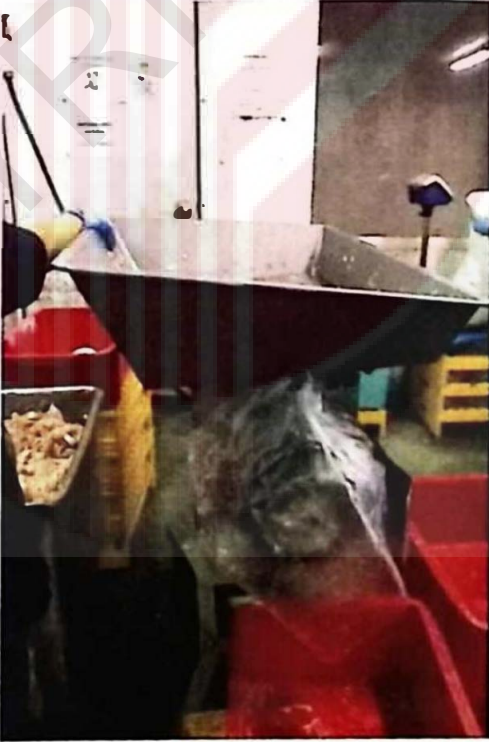
<p>Large amount of water is needed to remove the minced meat flakes attached to the surface of machine</p>

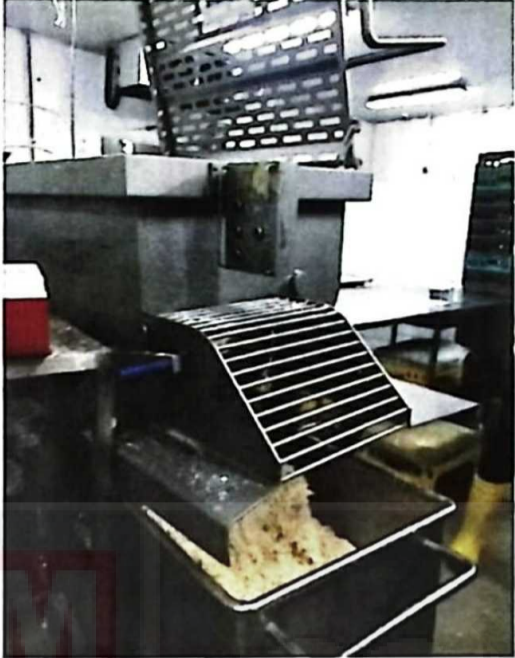
<p>5) Mixing of all ingredients</p>	<p>- Mixing of the minces with the premixed TVP, ISP, starch and spices to obtain a homogenized patty batter (visual and texture check).</p> <p>- The mixing was run for 15-20 minutes by an operator in accordance to the recipe</p>	<p>Mixing: Paddle mixer (maximal 420 kg/loading)</p>

<p>Large amount of water is needed to rinse away the meat fragments</p>
<p>6) Forming of patties</p>	<p>- Shaping of patty into a definite size and weight – Visual check on the patty shape was carried out by an operator and adjustment was made to the mould whenever necessary.</p> <p>- The forming station required minimally three operators: insert the batter into hopper, manually stack the patties and lay the paper separator</p>	<p>Forming: Former machine (3600 patties/h), compressed air necessary at minimum 8 bar</p>

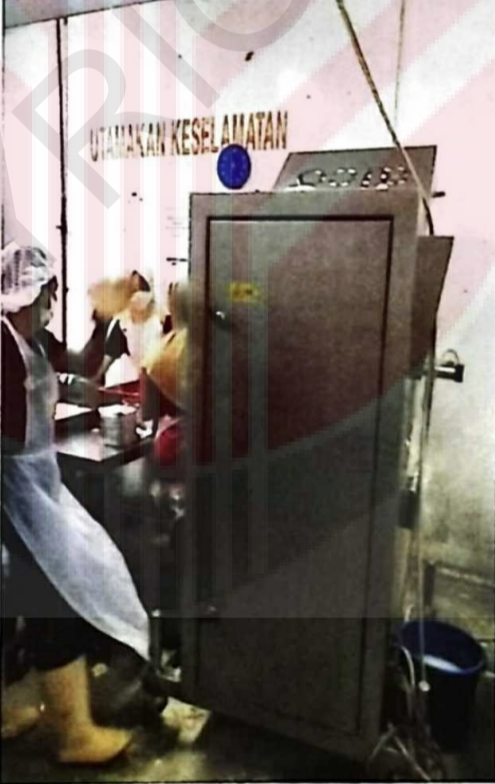
<p>Large amount of water is needed to lubricate the movement of the machine during processing</p>

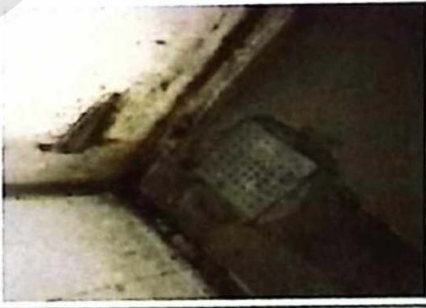
304.8 x 304.8 mm	Stainless steel square grating structure with perforated round holes Ø 12 mm without frame	A = 49 x 113.10 mm ² -5541.90 mm ²	<ul style="list-style-type: none"> No edge-infill, filter basket, odour seal (water trap) No gully body - inner side without smooth contours, crevices that can harbour dangerous bacteria 	<ul style="list-style-type: none"> Drainage coverage for 5.4 m² floor area Located in front of cold room Not in use since the wastewater is not flowing to this drain
2

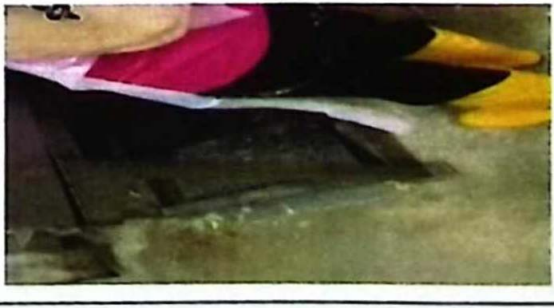
508 x 508 mm	Stainless steel square grating structure with perforated round holes Ø 10 mm without frame	A = 81 x 78.54 mm ² -6361.70 mm ²	<ul style="list-style-type: none"> Does not have peripheral accessories (spigot outlet, foul air trap (FAT) and sediment basket strainer) Grating have no frame 	<ul style="list-style-type: none"> Installation for coverage of 29.6 m² Falls are available only on two sides of drain Application is for draining production clean down and equipment discharge Grating not easy to remove, difficult for cleaning

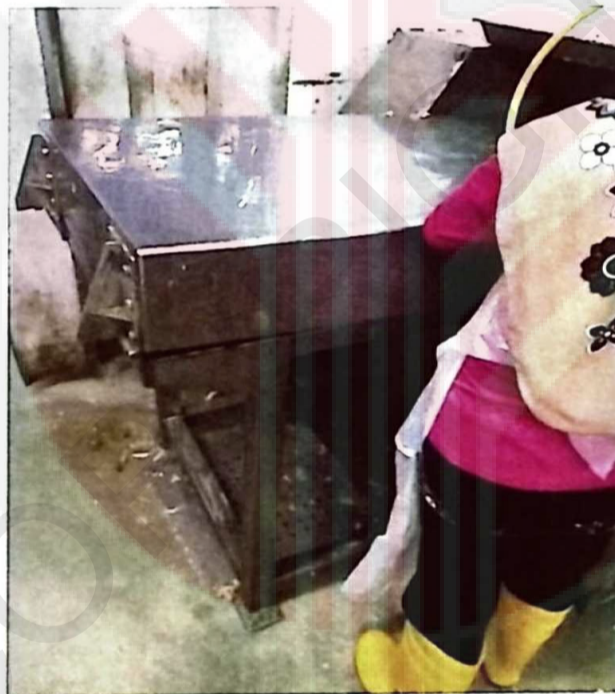
Figure 4.2.2: waste water flow down from flaker machine

The wastewater produced by Factory Y is mainly based on two sources namely 1) equipment and utensil clean down 2) equipment discharge from former and flaker machines as shown in Figure 4.2.2. Wastewater discharged from meat processing contains high total organic content (TOC), biochemical oxygen demand (BOD) and total suspended solid (TSS), pH range from 7-8 which is optimum for microbial growth. All wastewater is directed to the wastewater treatment which is located at the back of factory. The average hydraulic load, H_L supplied for production at Factory Y was estimated at 1.2L/s.

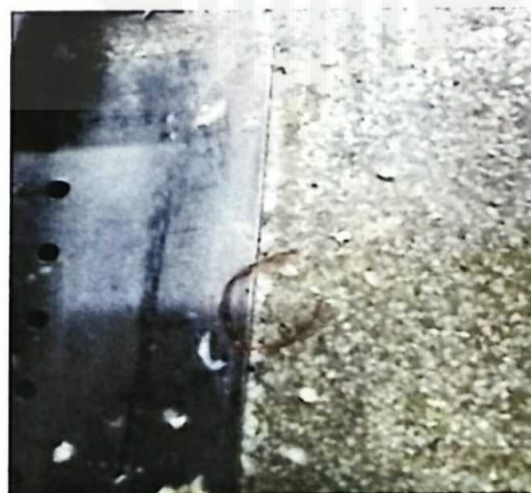
Figure 4.4 1: accumulation of soils at floor-drain interface

Drain Y showed lack of hygienic design. There have been found that numerous crevices and pit growth on the surfaces, dead space at the floor-drain interface due to absence of hygienic edge profile which harbor the growth of bacteria and microorganisms. Besides, drain Y is not installed with gully body, but is made of concrete (flooring materials) which is not protected by any screen. No filter basket is available to capture the solid waste. Besides, drain Y has no water trap to prevent the escape of foul air into the surrounding, and also no frame to hold the grating.

With such poor design, Drain Y could not be effectively cleaned even when the disinfectant was used. In addition, Drain Y was inappropriately installed below the cutting equipment as seen in Figure 4.4.1 due to negligence in reconciling the plant and plumbing layout design. It was therefore difficult to access Drain Y for frequent cleaning and maintenance. The grating is installed directly on the flooring surface and was not supported by stainless steel frame, which caused the drain edge to be above the floor surface and led to continuous accumulation of soils around the drain as shown in Figure 4.4.1. The intricacies of the overall cleaning process has also demotivated the operators on performing the cleaning of Drain Y, whereby in one incidence the clog were not cleaned at all until the next day of production.

Soil water inside the gully body has high aerobic plate count (APC) is 8.1×10^4 CFU/cm² followed by 2.4×10^6 CFU/cm² in grating surface, 4.5×10^6 CFU/cm² in perforated holes, 5.3×10^6 CFU/cm² in drain edge. The highest ATP values were also recorded for the soil water inside the Drain Y body, followed by drain edge, hole surfaces and grating surfaces. On the other hand, high level of Escherichia coli (1 CFU/cm²) was found in the soil water inside the drain, 25 CFU/cm² in grating surface, 2 CFU/cm² in perforated holes, 17 CFU/cm² in drain edge. The inner surface of Drain Y body was highly contaminated due to multiple reasons. The absence of filter basket allow the solid waste including the fats and proteins to sediment on the body's surface. The acidic nature of animal fat and proteins waste had attacked and corroded the unprotected concrete, weakening their structures and breaking them down little by little. Additionally, the acidic compounds reacted with the alkaline cement paste, which was the binder for the concrete structures and making it vulnerable to damage from abrasion, hot water cleaning, and further chemical attack. Such impacts had left the surfaces underside to be uneven with crevices and many dead spaces that could not be effectively cleaned and thus, had entrapped and accumulated organic soil, giving highest ATP value of 11657.
